INFORMATION REPORT

COUNTRY	Bulgaria	REPORT	
SUBJECT	Merchant and Military Information Concerning the Port of Burgas	DATE DISTR.	28 October 1953
		NO. OF PAGES	4
DATE OF INFO.		REQUIREMENT	
PLACE ACQUIRED		REFERENCES

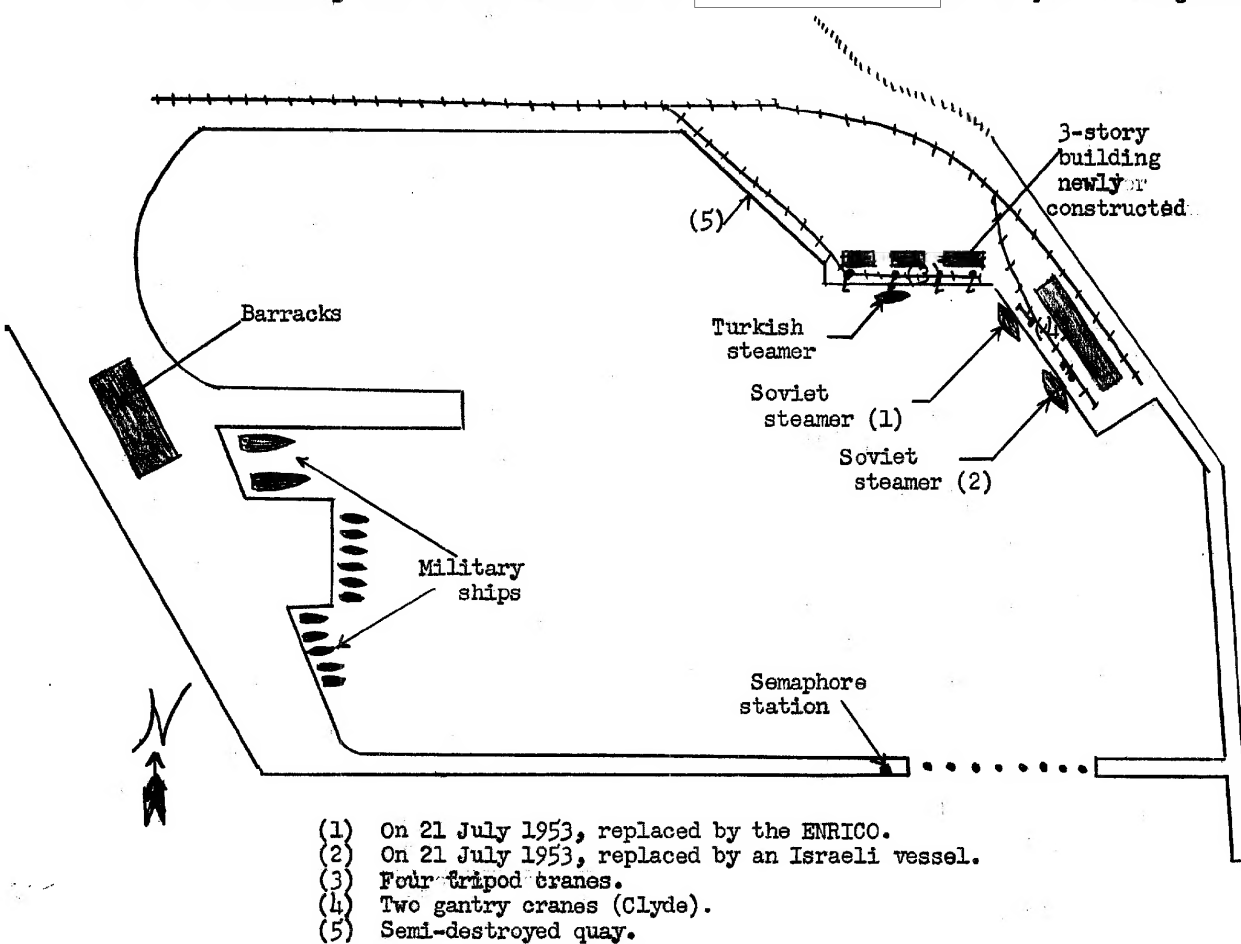
4. As indicated in the sketch on page 2, the west quay has a large 1-story masonry shed of old construction, with spur rail lines on both sides. On the quay there are two gantry cranes of 15 ton capacity, running on tracks and equipped with driver's cabin and unjointed slewing arm extensible to about 10 meters.

5. As indicated in the sketch on page 2, the north quay (still on the east side of the port) has three buildings. The eastern one, a new construction, is three stories high; the middle one, of old construction, is one story high; and the

western one serves as Customs headquarters. The quay is equipped with a spur rail line, and has three beak-type tripod cranes running on tracks, about three tons capacity each. In the vicinity of the west corner of this quay, another crane of the same type and capacity is under construction. [redacted] motor 25X1 parts [redacted] hoisted from a floating pontoon with a fixed gantry crane. 25X1

6. The remaining quay, beyond the corner mentioned above, is still damaged from World War II, and no signs of restoration work were noted.
7. A 3-story barracks in which Naval personnel are quartered is located in the western part of the port. On the quay in front of this building, moored straight in, were the ships which entered the port on the evening of 16 July 1953.
8. The following sketch shows installations [redacted] at the port of Burgas: 25X1

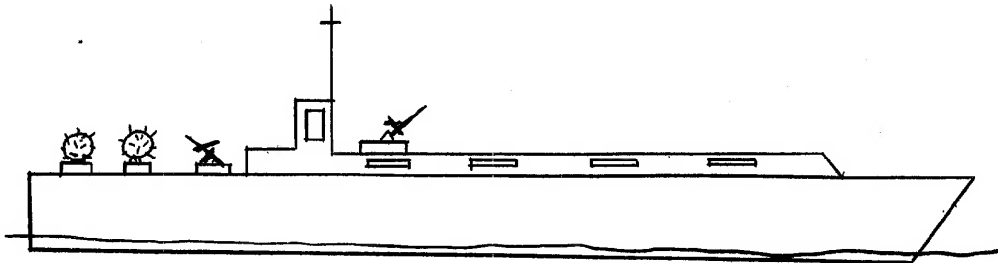
- a. Three German-type landing craft, with unloading doors in the prow, having on board landing troops with complete battle gear; the troops who could be seen wore helmets and were armed;
- b. Two landing craft carrying spherical mines (with spikes) on the stern of the deck; iron guide rails for rolling the mines were arranged on either side; the ships were armed with two 20 mm. guns, one toward the prow and one toward the stern of the bridge; no torpedo tubes were seen; troops were inside the hold;

- c. Escorting the three landing craft were four light units of the subchaser type, which had on board cylinder-shaped depth charges which slide on special iron guides; they were armed with machine guns [REDACTED] judged to be eight mm., one toward the prow and one toward the stern of the bridge; the length of the boats was estimated at about 20 meters; 25X1
- d. Six or seven motorboats of the type used in coastal patrol, but a little smaller than the subchasers; these were armed with two small-caliber machine guns, set toward the stern; and
- e. One motor torpedo boat, which appeared to be of German type, with two launching tubes cut into the superstructure, one on each side, at the height of the command bridge, open at one end; it is armed with a machine gun of unknown caliber [REDACTED] 25X1
